the fabric engineer

february 2001

Fire in Fabric
Buildings - a
case study

Lifespan of
Steel Framed
Fabric Structures

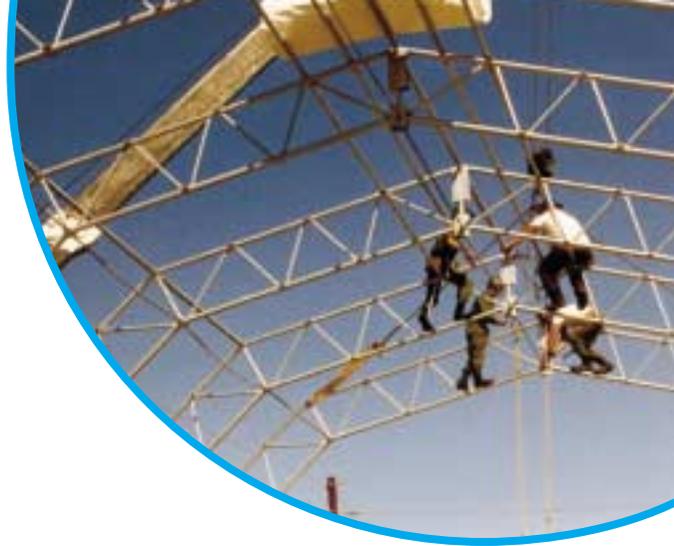
Typical truss framework for a Rubb structure

3. Hot Dip Galvanized Framework - In this process black steel is welded together to form a complete fabricated piece. The fabrication is then hot dip galvanized to ASTM A123 specification to provide a zinc coating on all steel surfaces. This process involves full immersion of the structural fabrication in a molten zinc bath and provides a much thicker zinc coating than that of pre-galvanized products. In most environments, the hot dip galvanized coating used by Rubb will be expected to last a minimum of 40 years before initial maintenance is required.

Rubb hot dip galvanizes all welded fabrications in its structures to provide for superior corrosion protection. As the frame is fully galvanized after manufacture there is no paint to chip, no potential weak spots where rust can develop and the thicker zinc coating provides for superior long term performance. For extremely harsh environments, Rubb can offer duplex coatings which consist of hot dip galvanized steel that is painted or powder coated following the galvanizing process to provide extra protection.

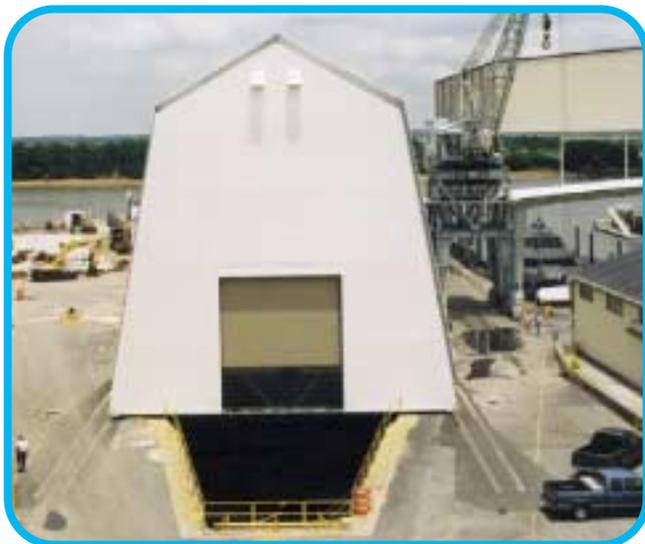
58' vertical sidewalls - the highest to date for Rubb

At Rubb, Inc. in the USA we have erected the largest clear span Rubb facility to date. This is a 255' wide, 4-5 million cubic foot, hangar for United Airlines at Logan International Airport in Boston. In addition, Rubb, Inc. has delivered one of the highest sidewall fabric structures to date to Intermarine Shipyard in Savannah, Georgia. Vertical sidewalls are 58' with an overall maximum height of 73'.

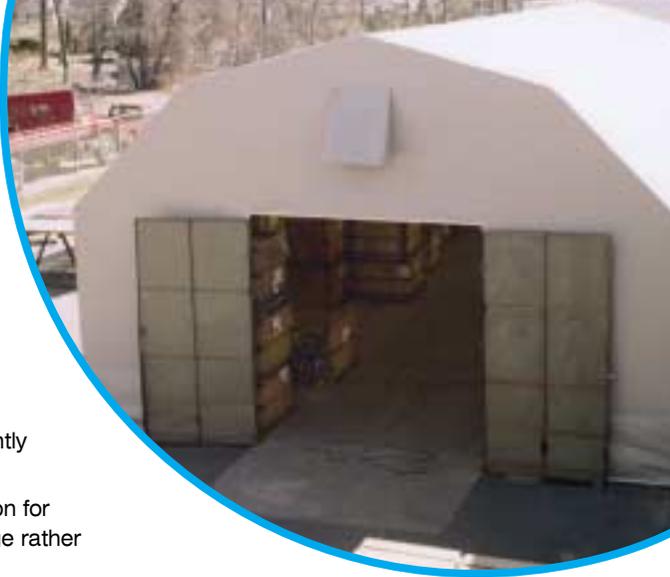
Membrane replaced after 25 years - not because of age, but due to operational damage

A relocatable Rubb building measuring 33' x 70' has celebrated 25 years in service with a new PVC replacement cover for its hot dip galvanized steel frame.

A sample of the 25 year old fabric was sent for laboratory testing which confirmed that its flame retardant characteristics were still present. The original tensile strength specification has also been maintained. Only the fabric's tear strength has been slightly reduced after 25 years.

"Although the fabric was 25 years old, the facility at Peck & Hale could have carried on for many more years had the membrane cover not been affected by operational damage rather than the aging of the fabric", commented John Poulin, Rubb, Inc.'s Sales Manager.

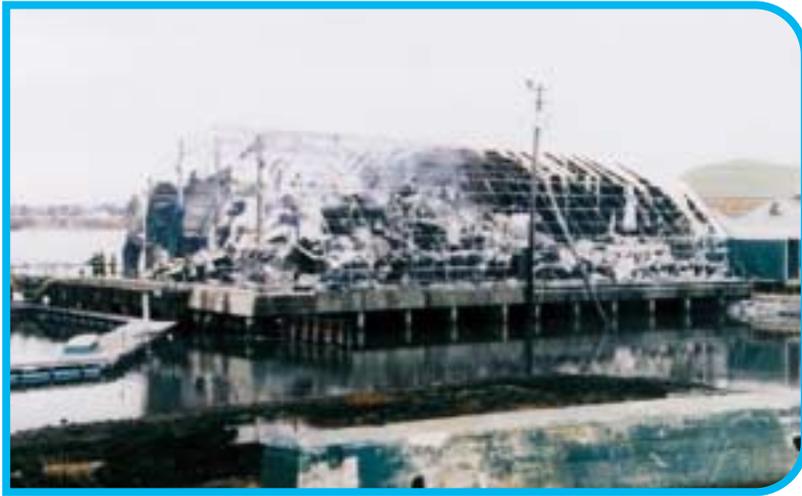
The Rubb structure is intact after a severe fire in a paper storage warehouse

At 3 am on a November morning in 1999, a fast spreading fire engulfed a Rubb storage facility at the Merrill Marine Terminal in Portland, Maine. A stray spark caused hundreds of bales of scrap paper to ignite as fire swept through the 82' x 120' structure; one of four Rubb buildings at the terminal.

The fast spreading fire vaporized the Rubb PVC membrane allowing heat and smoke to escape and thereby preventing heat damage to the steel framework of the building. Fire personnel were able to fight the fire safely and effectively from outside the structure. Amazingly, the structure was back in service with a new PVC membrane in less than a week following this severe fire.

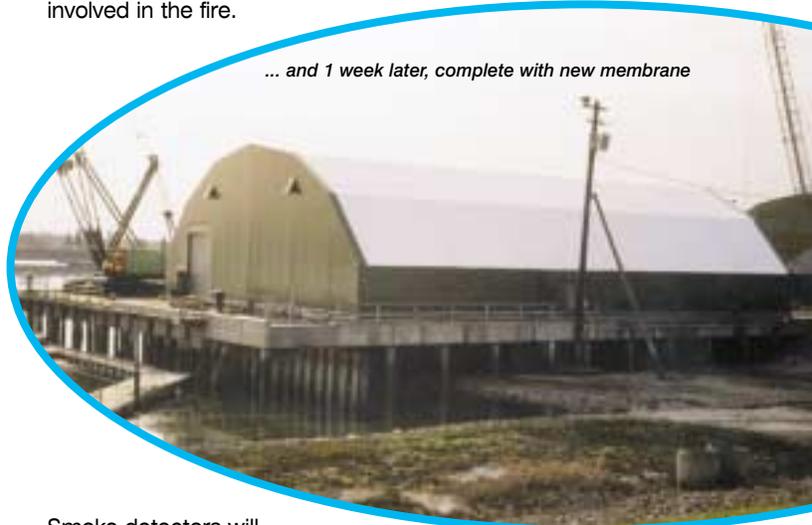
... and 1 week later, complete with new membrane

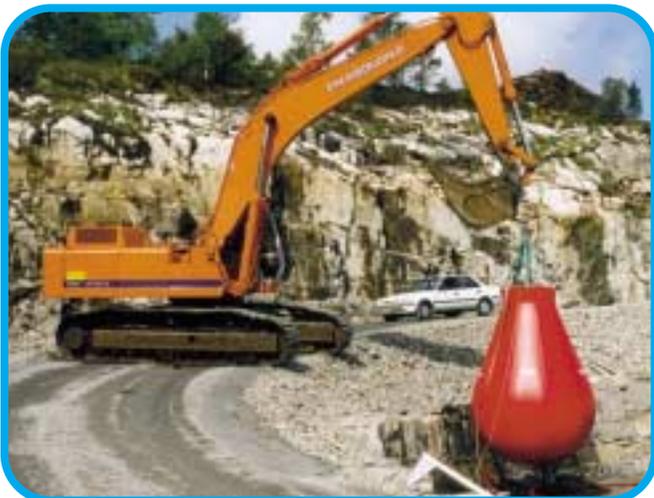
New 10 ton Aquaweight undergoes testing and passed, proving the strength of Rubb PVC

Aquaweights are the latest products to be added to the Rubb product line. They incorporate Rubb's substantial experience in fabric structures and are engineered and tested with a 5:1 safety factor.

Rubb aquaweights are ideal for testing the capabilities of cranes in areas where it is impractical to use concrete weights, such as the marine industry. Aquaweights are becoming increasingly popular for use on ships and offshore oil installations where water is easily accessible and where the strength, light weight and durability of Rubb PVC are a big advantage.

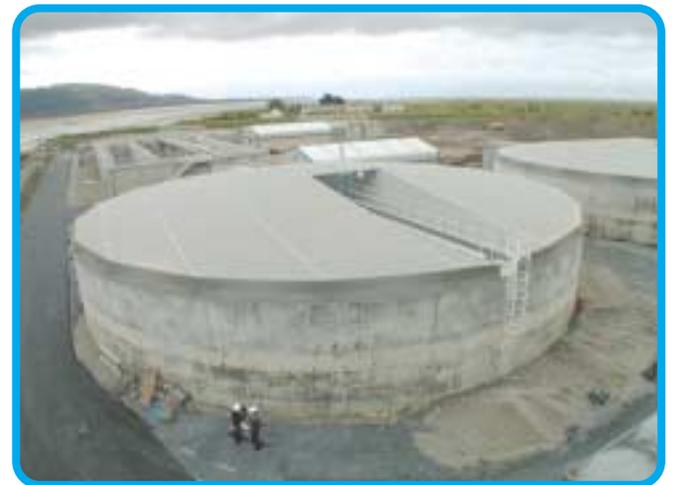
Odor control at Dundalk, UK

Rubb Buildings UK has completed a contract for the design, production and installation of two large 106 foot diameter covers for the control of odors generated by effluent treatment.

Each cover is constructed of a hot dip galvanized steel structure which is mounted onto the concrete walls of the tanks. The galvanized steel is provided with an epoxy paint finish to prevent corrosion of the framework and the framework is clad with Rubb's high strength PVC coated membrane.

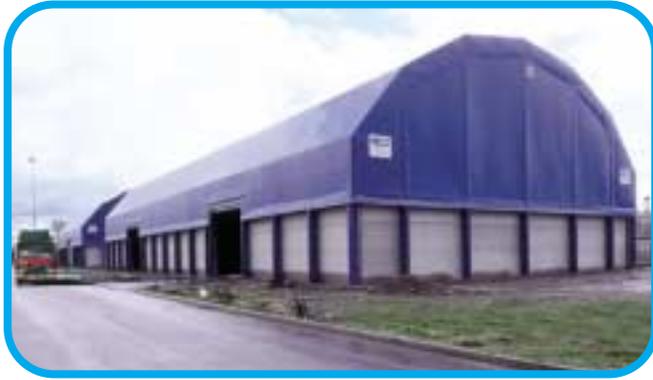
Animal food storage facility at Workington, UK

Ray Colby, Sales Manager at Rubb UK explains the solution to the client's problems: "Because that part of the west coast of England is susceptible to severe winds and rain we constructed our storage systems on top of 13' retaining walls."

"The walls consist of a steel support structure complete with pre-stressed concrete infill panels which allow for quick and easy construction. This method provides a fully sealed facility to prevent water ingress and also allows for internal retaining walls to be built for different storage needs."

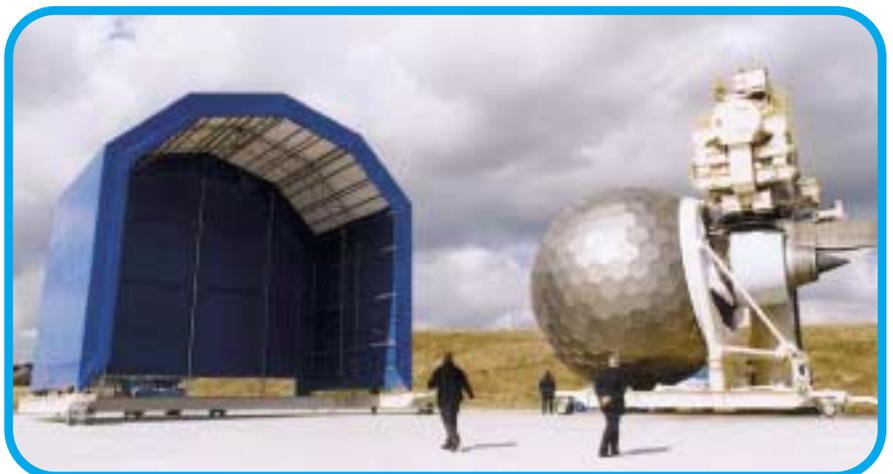
Trolley allows for the structure to be moved quickly if the weather changes
